Site 276 Kent's Island Creek

Great Marsh Coastal Wetlands Restoration Plan
Rapid Technical Assessment Site 276

Site # 276
Kent's Island Creek

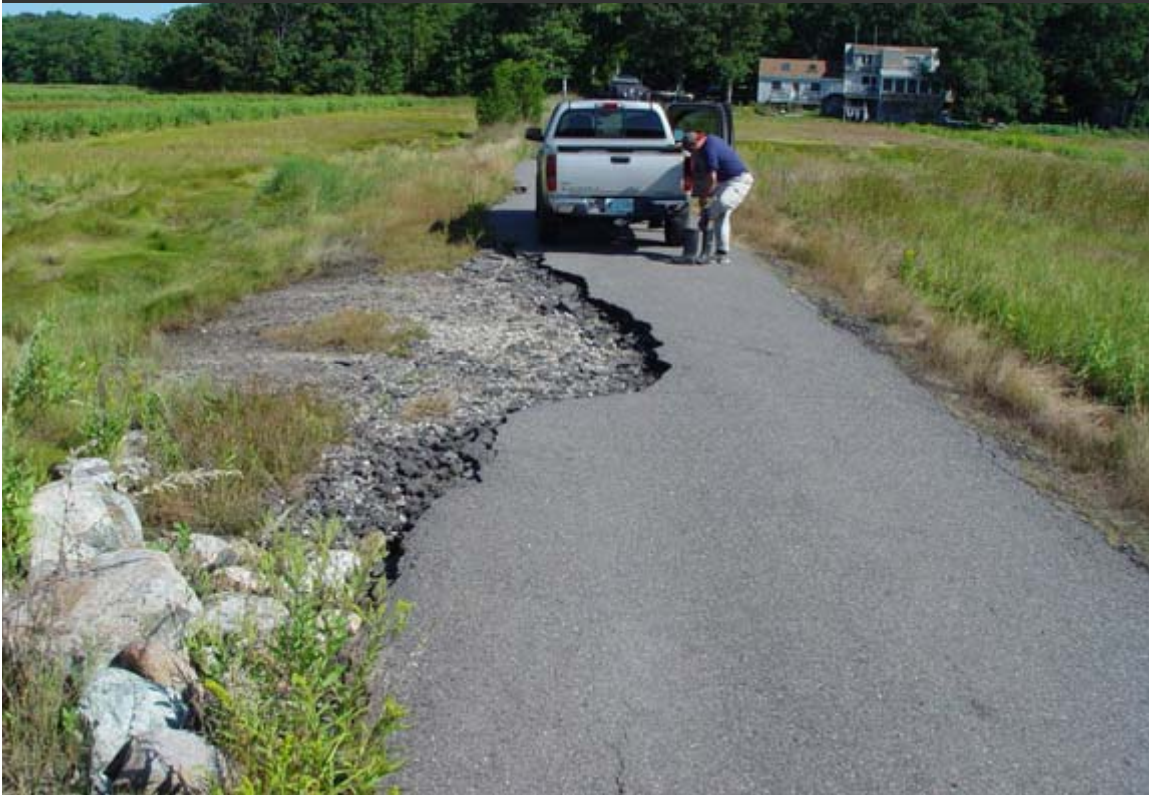
Photo 1 - Access Road North of Bridge Crossing Viewing North

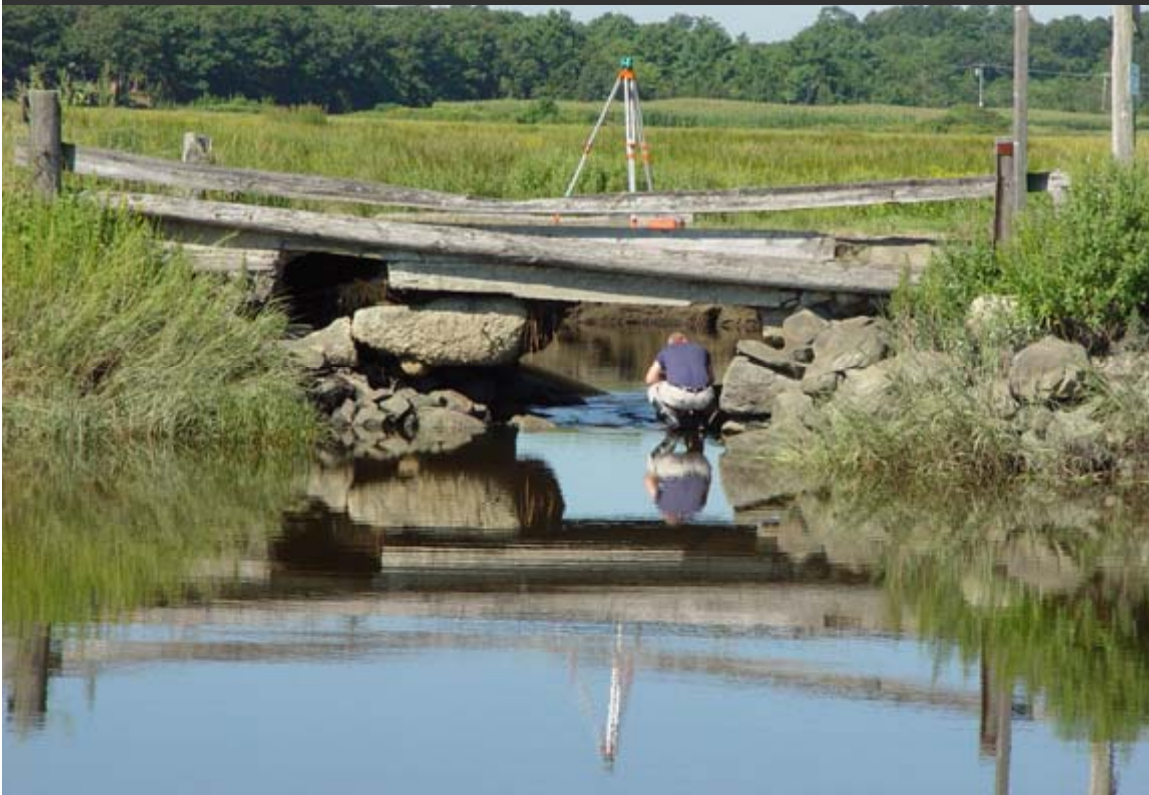
Photo 2 - View of Upstream Side of Bridge Crossing

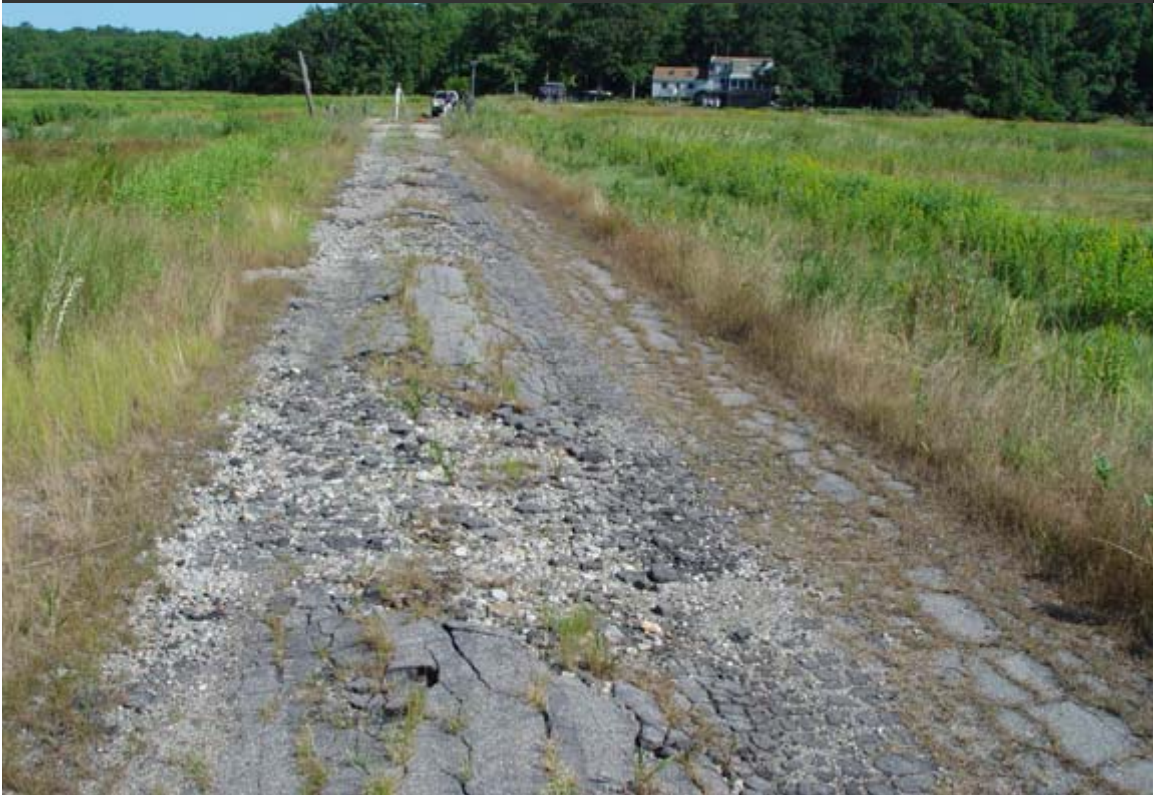
Photo 3 - Access Road South of Bridge Crossing

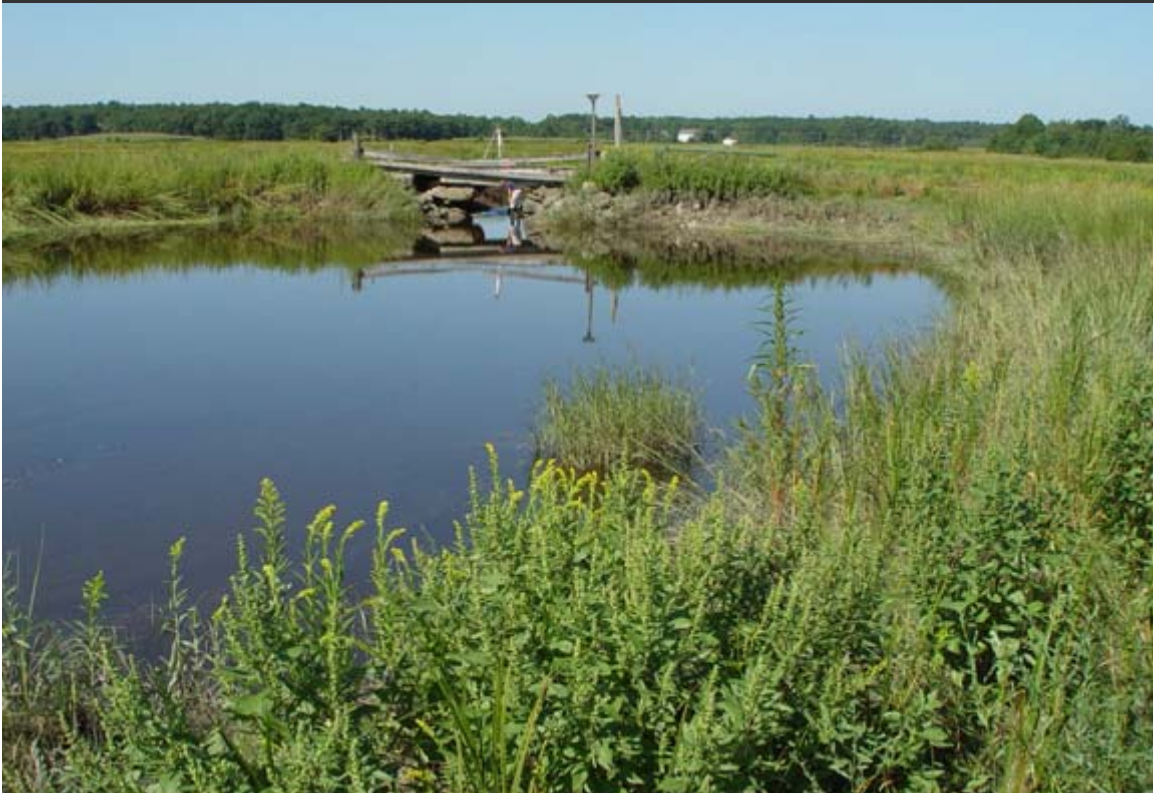
Photo 4 - View of Downstream Side of Bridge Crossing

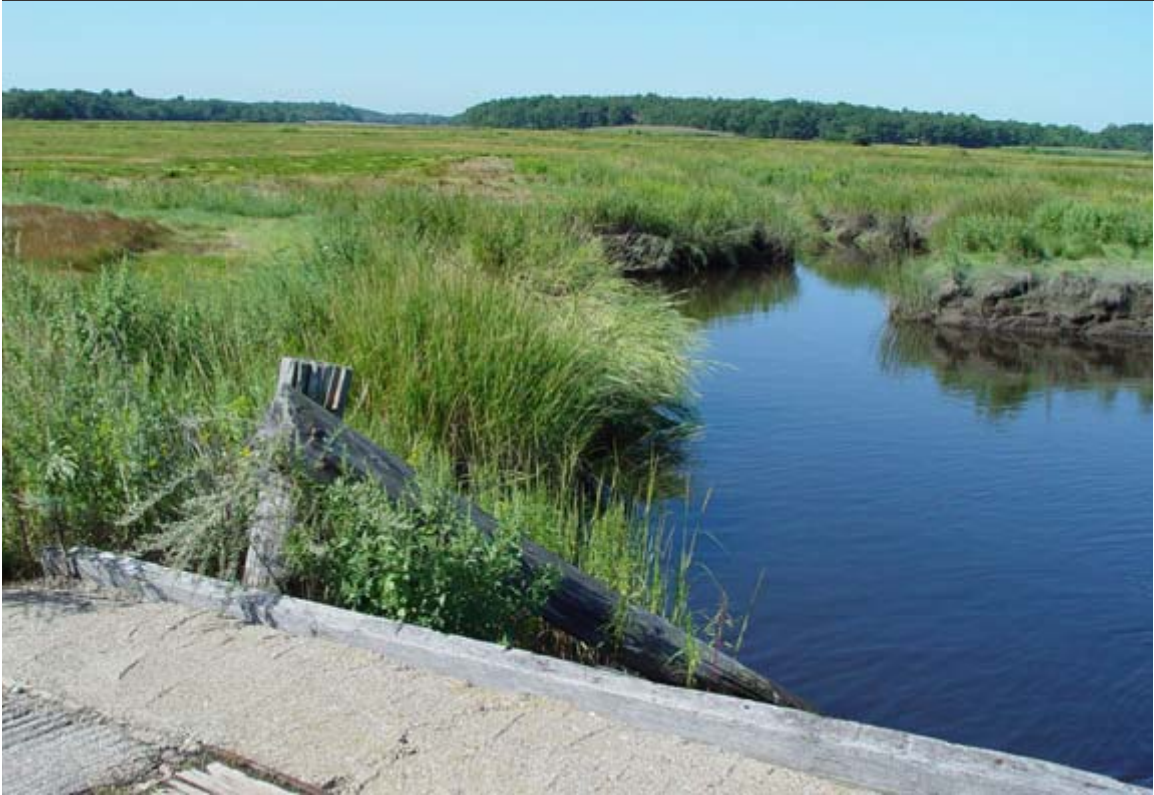
Photo 5 - Salt Marsh Upstream of Bridge Crossing
